# Manhole Inspection Summary

Manhole # S51M\_\_066MH

**Location** Address: **901 S Streeper**

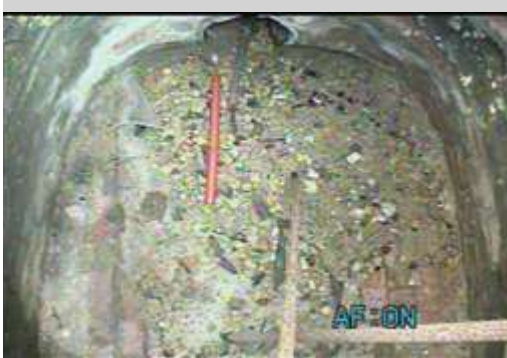
MISC

channel debris

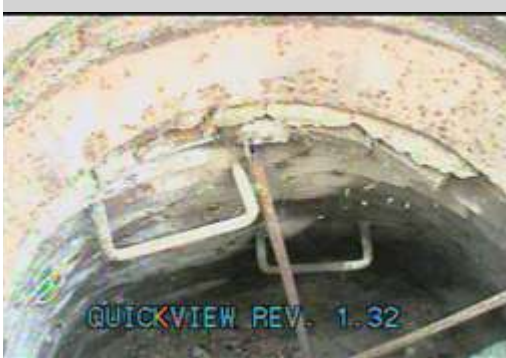
Defect 2

**Steps** Count: **2** Missing: **0** ☒ **Corroded**

corroded stairs

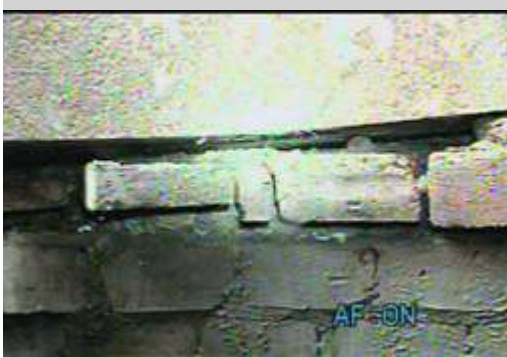
Defect 1

Condition: ☐ Sound ☐ Cracked ☐ Root Intrusion ☒ **Loose Brick** ☐ Deteriorated

chimney loose brick frame adjustment
